**Record Photographs
of Works**

**THE CATHEDRAL CHURCH OF
THE BLESSED VIRGIN MARY
AND ST ETHELBERT
IN HEREFORD**

**Completed Repairs to the
North Aisle and part of the
South Quire Aisle Roofs**

9th February 2018

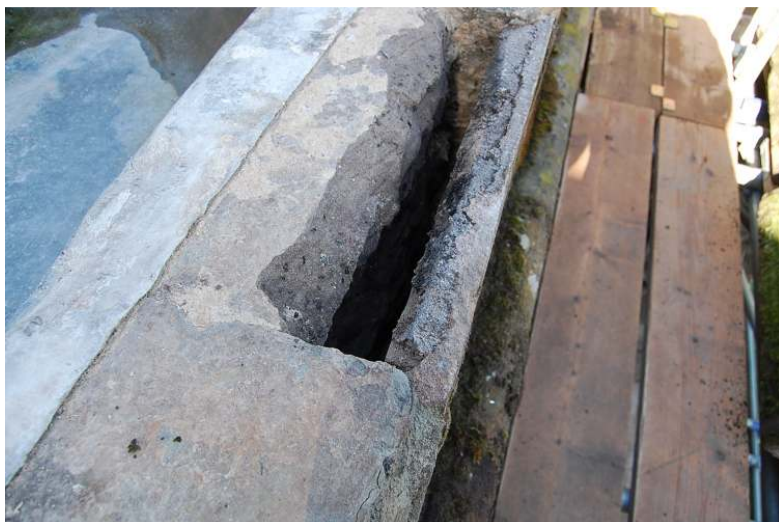
Previous thin facing repair below coping level cut out for a 100mm deep block with only a thin edge bedded facing provided as a replacement. This was removed and full depth stone used to replace it.

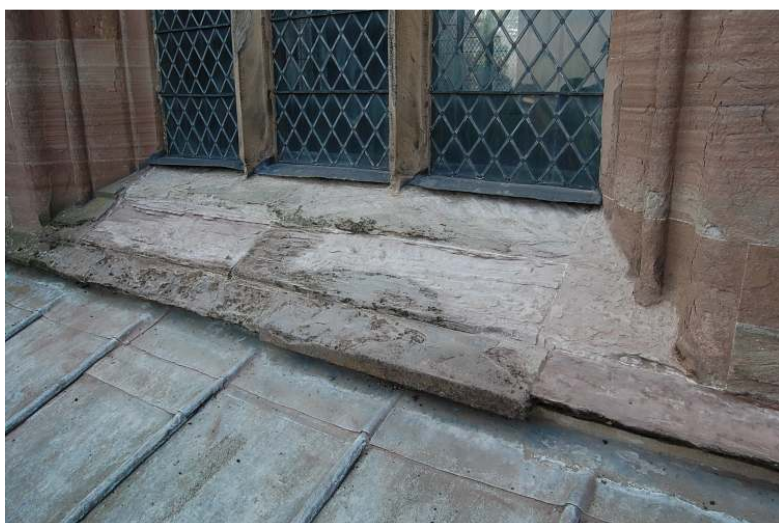
Concrete render partly removed from sills.

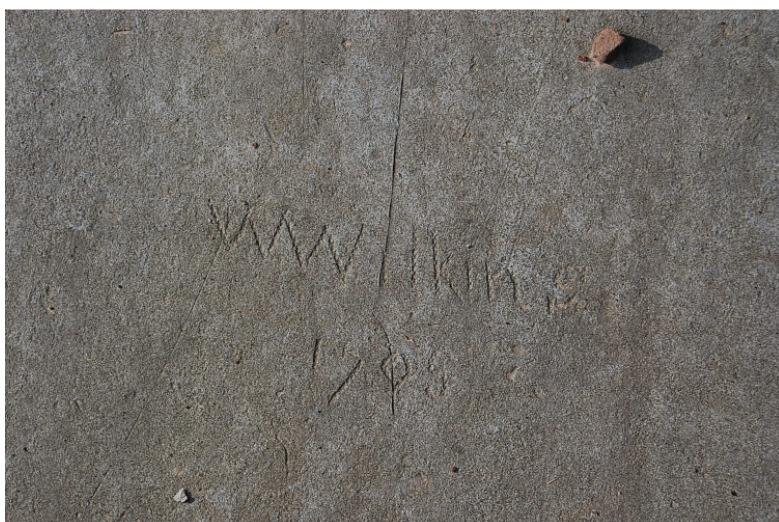
North Aisle lead graffiti "W Wilkins 1795" that was cut out and re-welded into a cover flashing sheet. This date is just after the James Wyatt contract that commenced in September 1788.

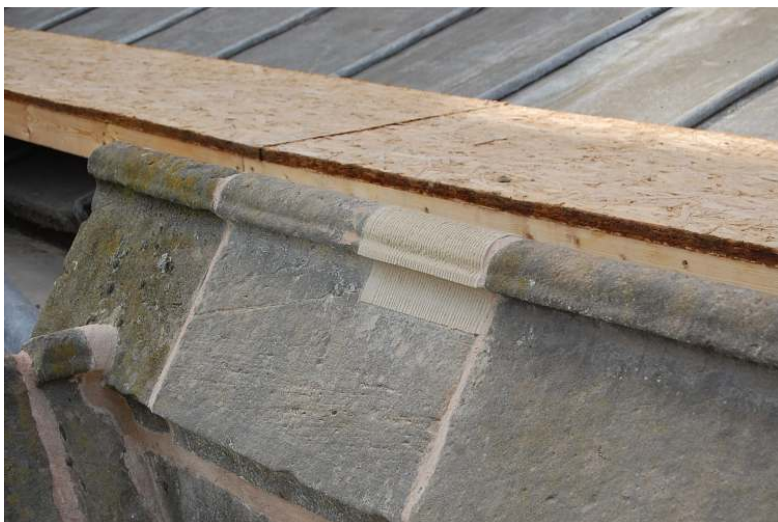
Stone coping with indent repair.

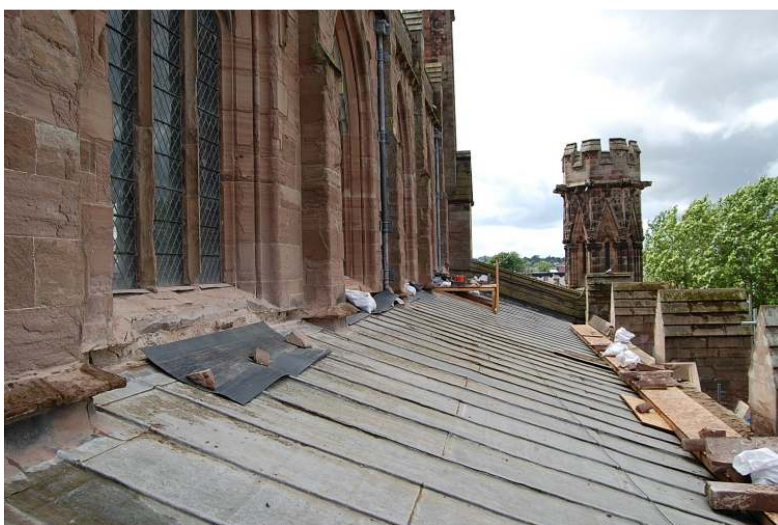
Stone sills and string course cut out.

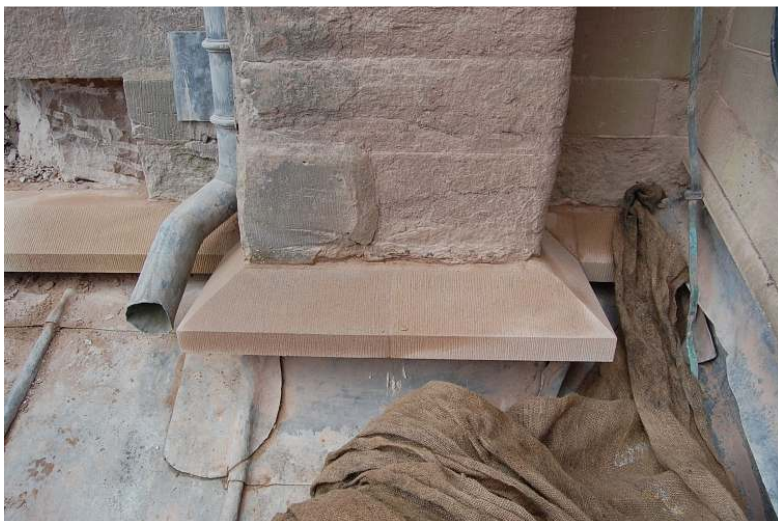
Replacement string course in place.

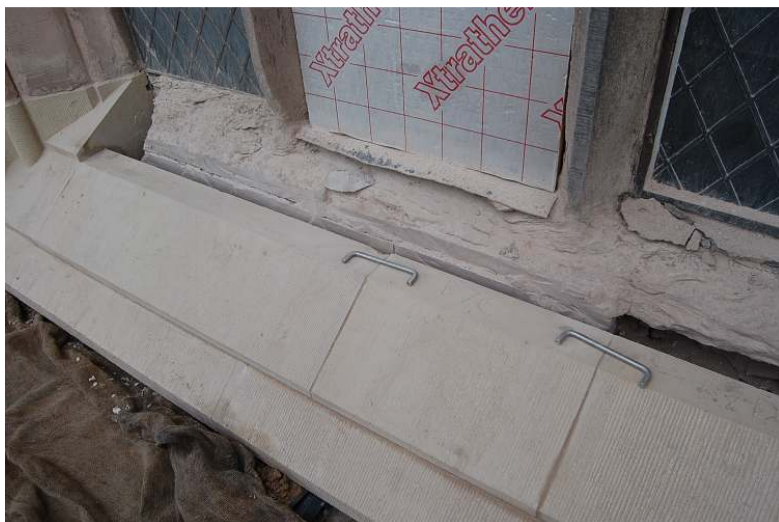
Sill stones with stooling to left jamb and dog cramps awaiting fitting and back grouting.

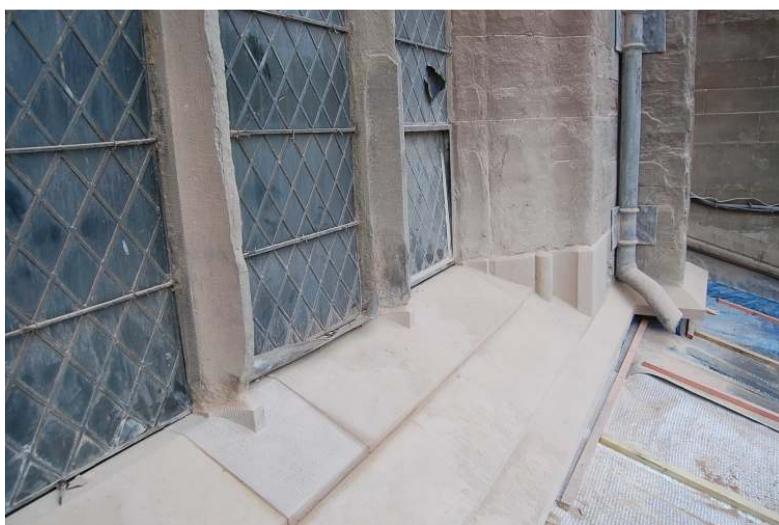
Completed sill, stoolings and string course.

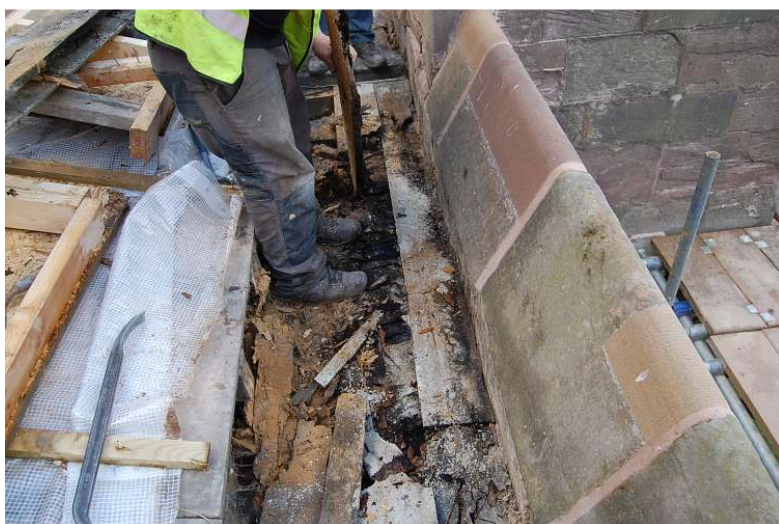
Timber repairs to gutters showing the extent of the decay. James Matthews wrestles with a decayed board.

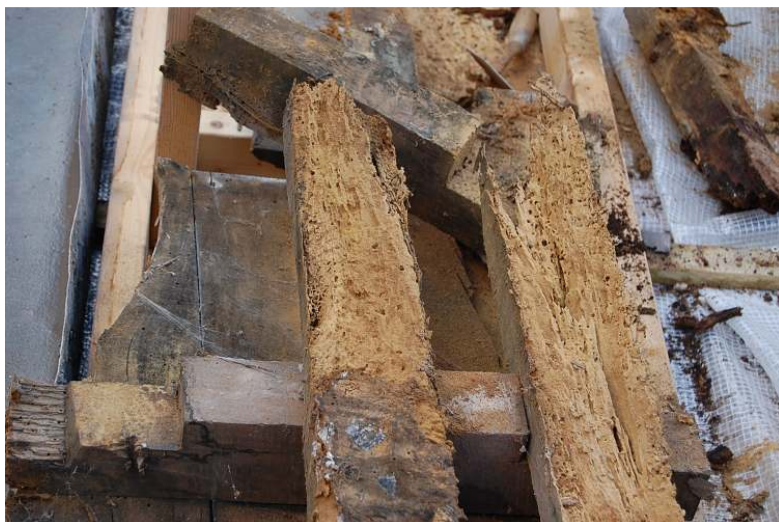
Gutter bearers turned upside down to show the extent of their decay.

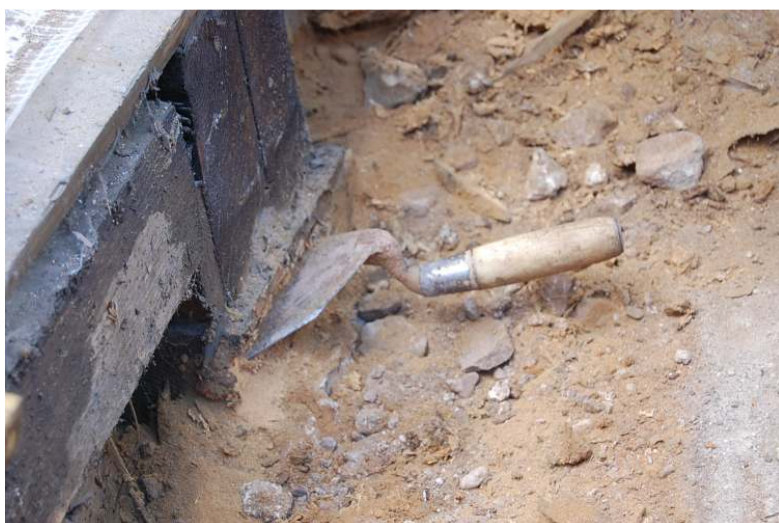
A rather soft truss tie beam bearer.

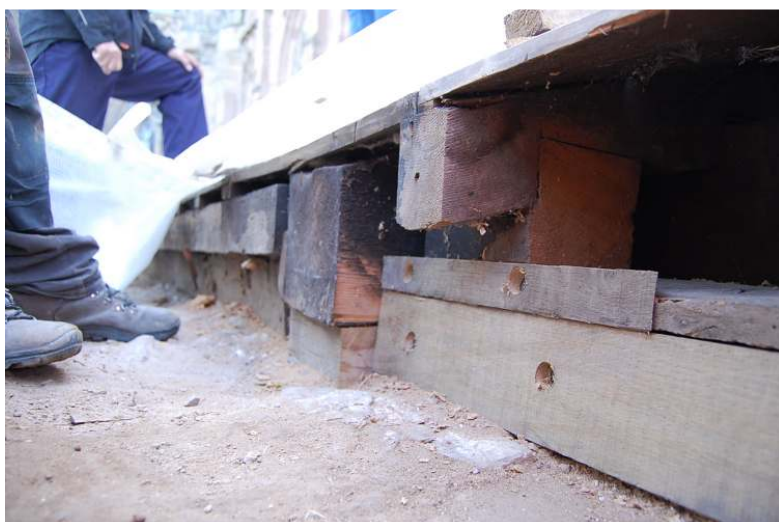
The same bearer following repair.

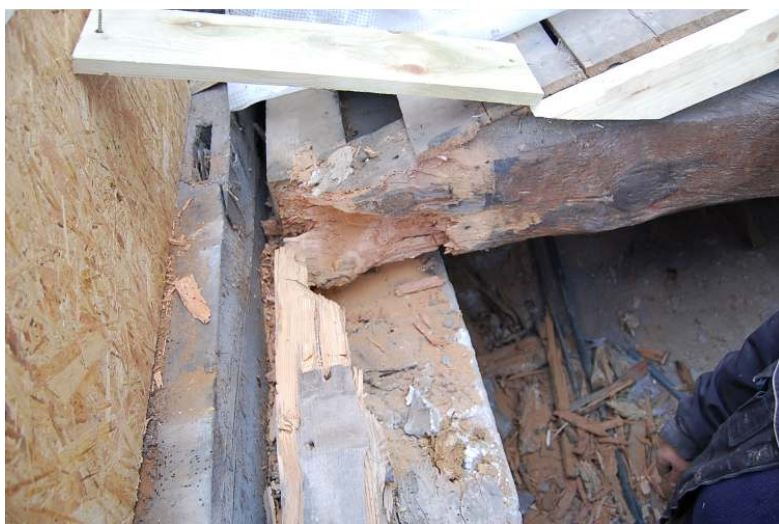
Decayed truss end that required a steel plate.

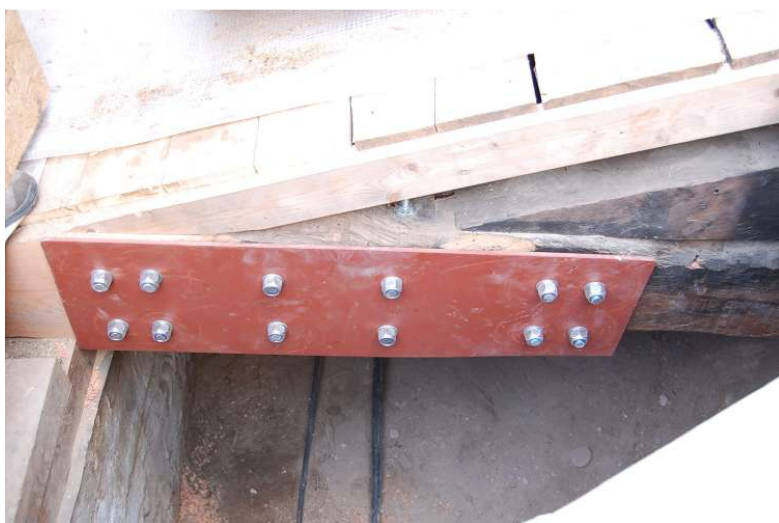
Steel plates both sides of the tie beam hide a new bridled scarf joint but allow as much of the original to remain as possible. Crude but effective.

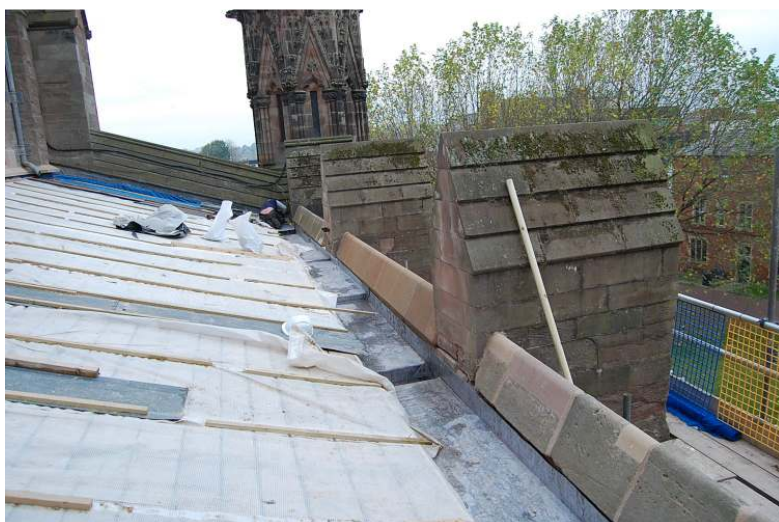
Following timber repairs the parapet gutters are lined with lead.

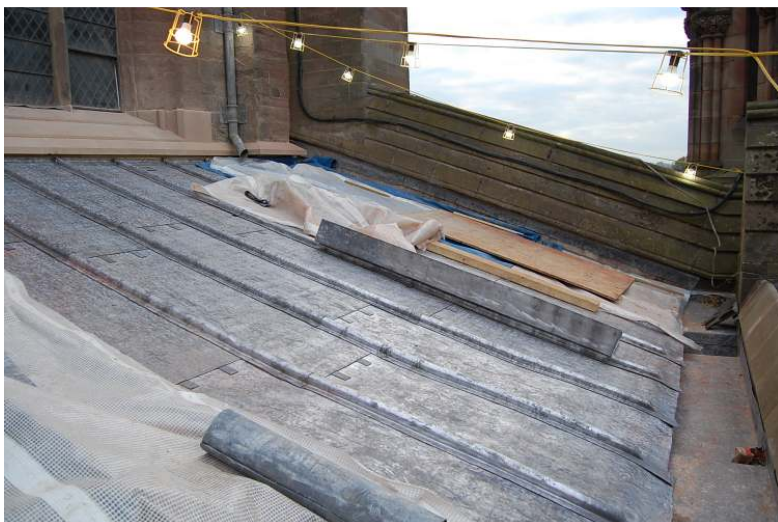
The lead sheets to the roof covering are laid from west to east so that the cover lap is on the leeward side of the prevailing wind.

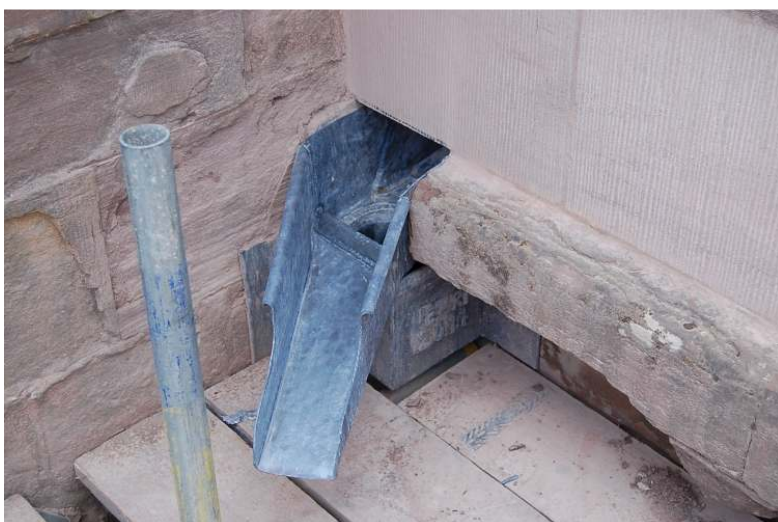
New lead overflow and chute.

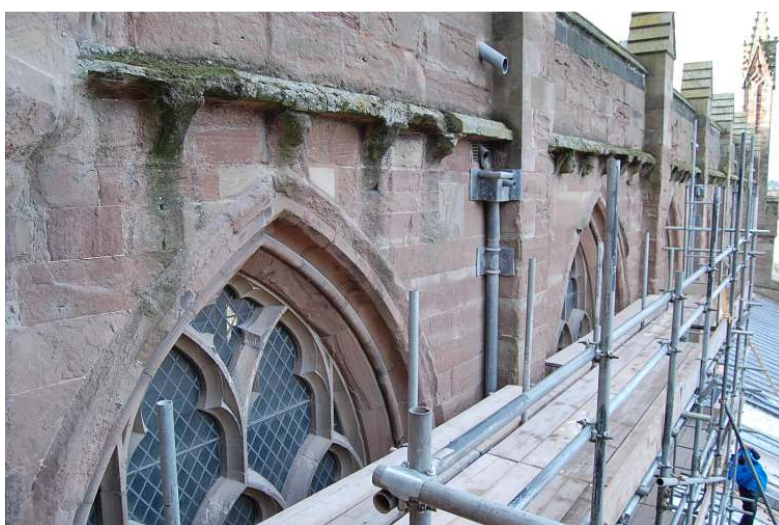
Bay 1 & 2 clerestory decayed hood mouldings about to be cut out. The repairs to the corbel table and corbel stones could not be accommodated within this project.

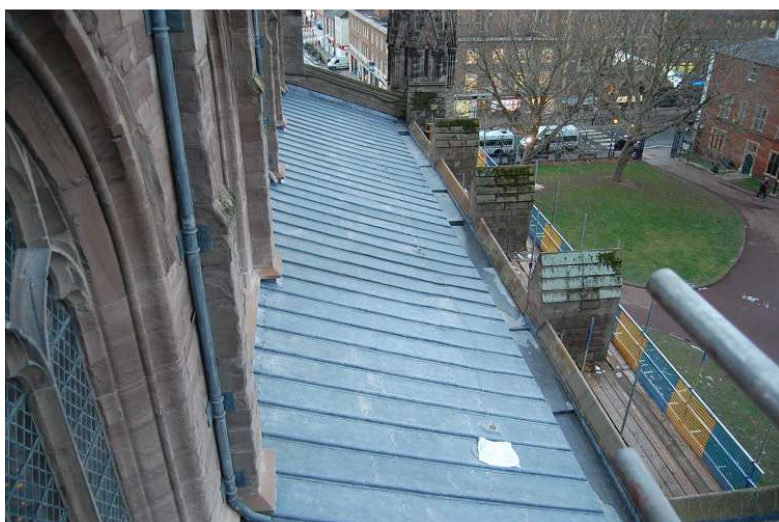
Completed lead bays.

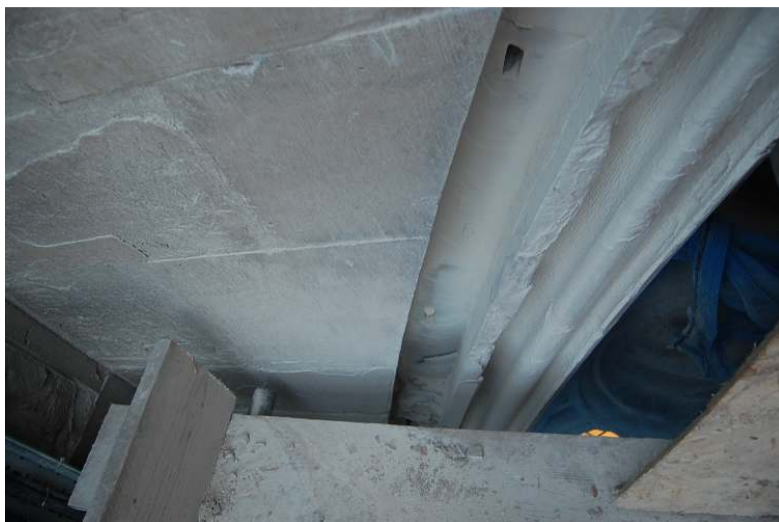
Hood mouldings cut out awaiting replacement.

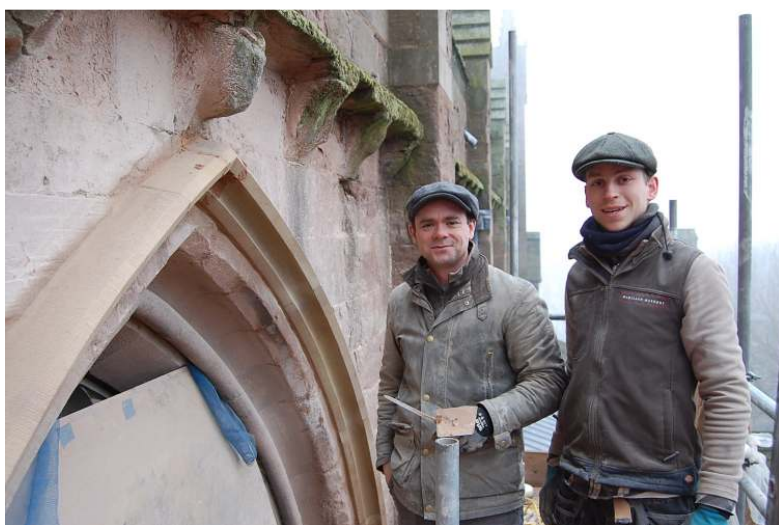
Tom McMillan & Tom Holder from McMillan Masonry point up the new hood mouldings. Only the first two bays from the tower could be repaired within the budget. Five further bays await future funding.

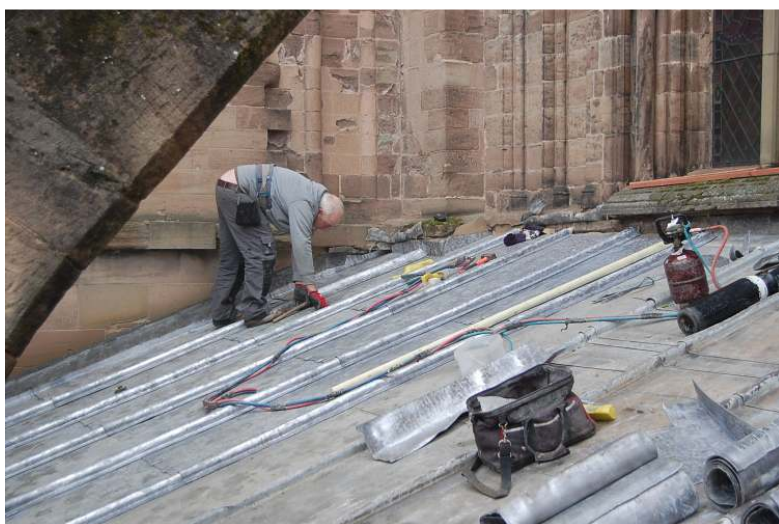
South Quire Aisle lead repairs in progress.

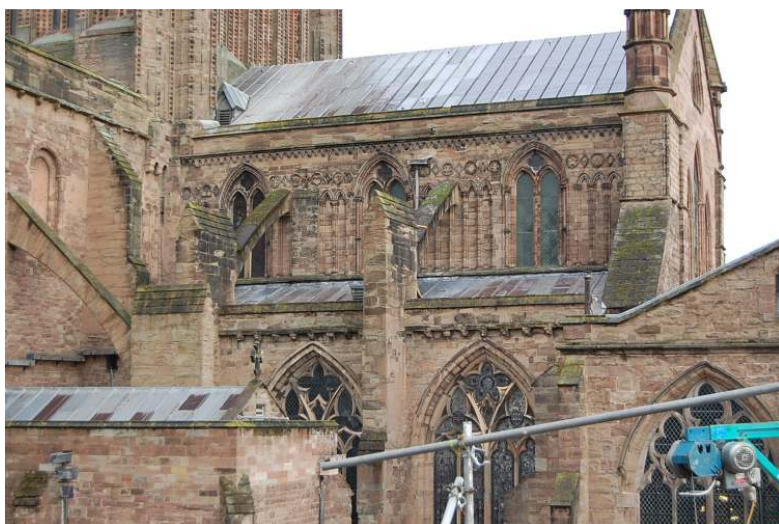
South Quire Aisle patch repairs and part replacement completed.

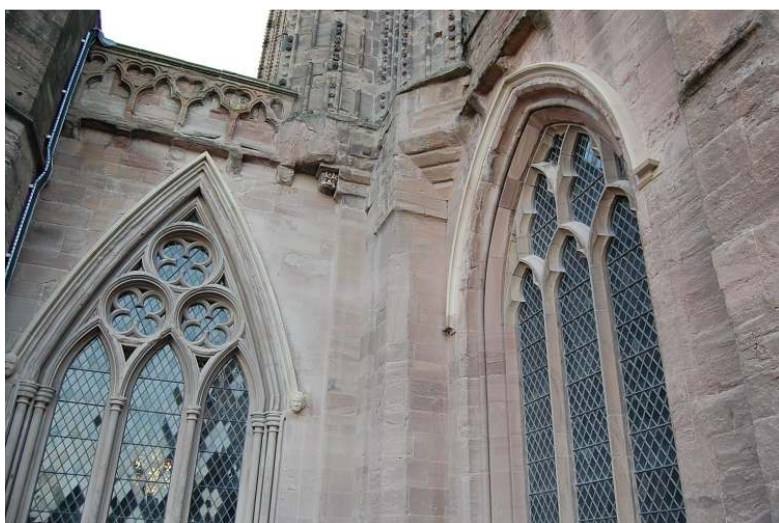
Completed hood mouldings to the North Aisle Clerestory and first bay of the North Transept.

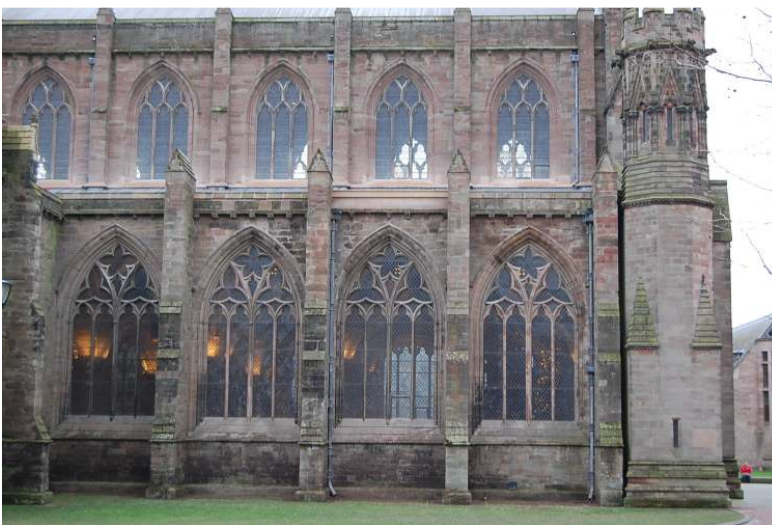
Lead and sills complete viewed from across the Close.

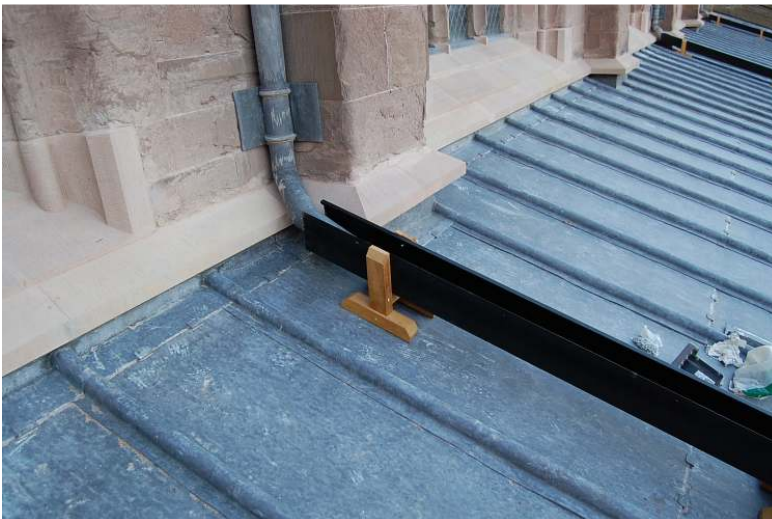
New trough collecting Nave roof rainwater goods.
